NASA Technical Paper 1379

Lubrication and Failure Mechanisms of Molybdenum Disulfide Films

II - Effect of Substrate Roughness

Robert L. Fusaro

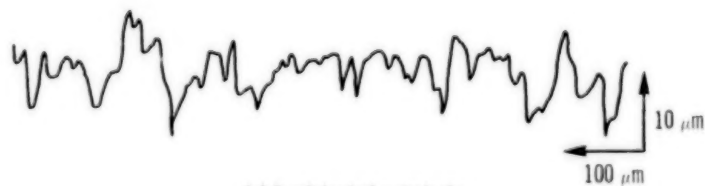
(a) Polished substrate.

(b) Sanded substrate.

(c) Sandblasted substrate.

Figure 3. - Photomicrographs and surface profiles of 440C HT stainless-steel disks with different surface finishes before application of rubbed MoS_2 films.

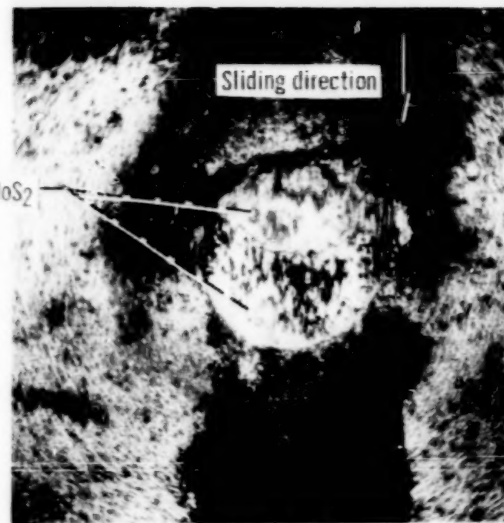
(a) Polished substrate.

(b) Sandblasted substrate.

(c) Sandblasted substrate.

Figure 6. - Photomicrographs (taken after 1 kilocycle of sliding in moist air (10 000-ppm H_2O)) of rider wear scars and wear tracks on rubbed MoS_2 films applied to 440C HT stainless-steel disks with different surface finishes.

Heavy, coalesced transfer films of MoS_2 were found after 1 kilocycle of sliding on the riders that slid on the films applied to the polished and sanded substrate surfaces. However, the transfer was not nearly as thick or continuous to riders that slid on films applied to the sandblasted substrate surface (figs. 6 and 8) probably because of the scouring action of the sharp metallic asperities on this surface. This thin transfer of MoS_2 did not increase the friction coefficient; in fact, a slightly lower friction coefficient was obtained.

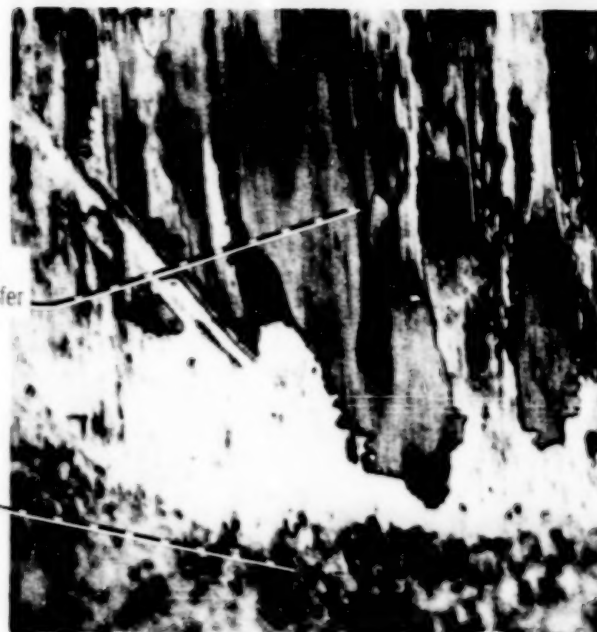
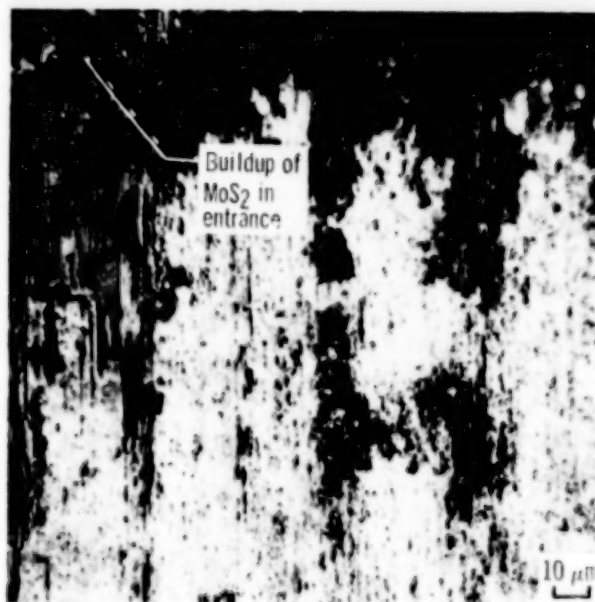
(a) Polished substrate (exit region).

(b) Sanded substrate (exit region).

(c) Sandblasted substrate (entrance region).

Figure 8. - High-magnification photomicrographs (taken after 1 kilocycle of sliding in moist air (10 000-ppm H_2O)) of transfer films on riders that slid on rubbed MoS_2 films applied to 440C HT stainless-steel disks with different surface finishes.

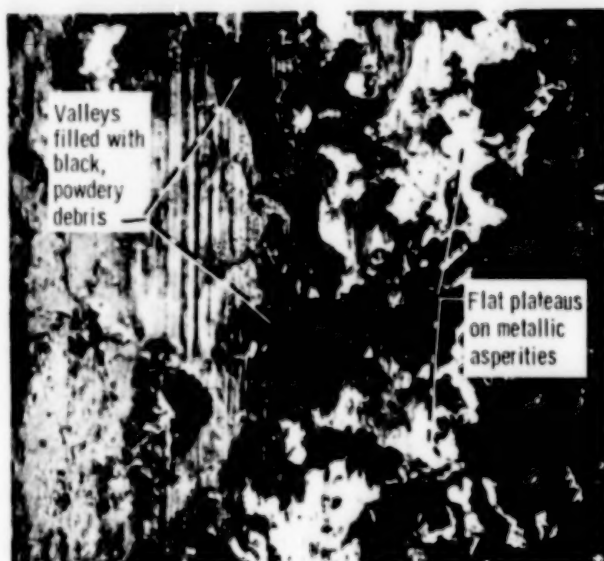
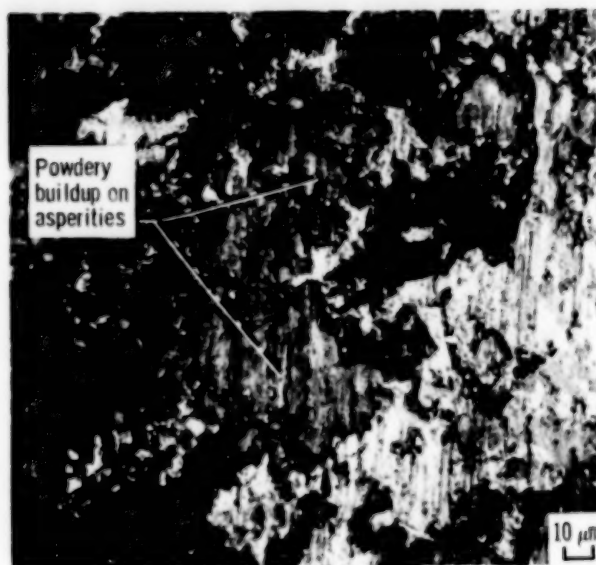
(a) After 5 kilocycles of sliding.

(b) After 15 kilocycles of sliding.

(c) After 60 kilocycles of sliding.

(d) After 70 kilocycles of sliding.

Figure 9. - High-magnification photomicrographs (taken after various intervals of sliding in moist air (10 000-ppm H_2O)) of wear tracks on rubbed MoS_2 films applied to sandblasted 440C HT stainless-steel disk surfaces.

Figure 9 shows high-magnification photomicrographs of the wear tracks on MoS_2 films applied to a sandblasted substrate surface after 5, 15, 60, and 70 kilocycles of sliding. As sliding time increased, more MoS_2 was transformed. Because more wear also occurred on the flat plateaus on the sandblasted asperities, new lubricant was exposed deeper in the valleys. Thus, the valleys in the rough surface served as reservoirs for the lubricant and as deposit sites for wear particles.

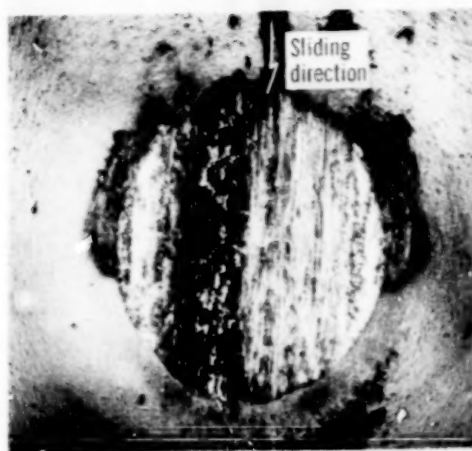
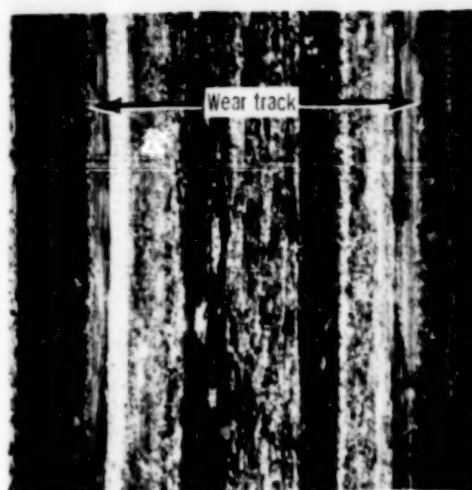
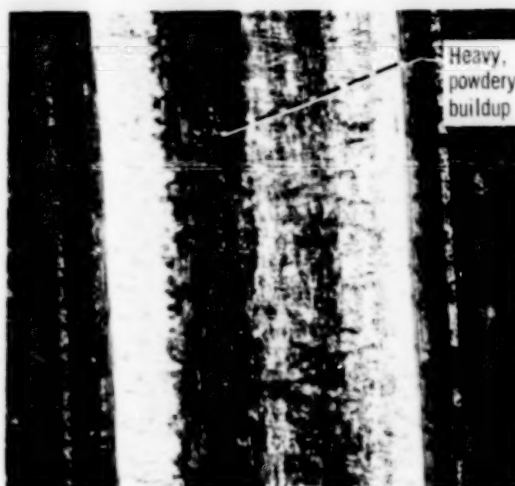
(a) Polished substrate (after 5 kilocycles of sliding).

(b) Sanded substrate (after 10 kilocycles of sliding).

(c) Sandblasted substrate (after 70 kilocycles of sliding).

Figure 10. - Photomicrographs (taken after failure in moist air (10 000-ppm H_2O)) of rider wear scars and wear tracks on rubbed MoS_2 films applied to 440C HT stainless-steel substrates with different surface finishes.

At failure, the film wear tracks and the rider wear scars looked much the same (fig. 10). There was a heavy, powdery buildup of transformed material on both these surfaces. The transformed material did not completely cover the wear surfaces but formed bands around the circumference of the disk wear track and parallel to the sliding direction on the rider wear scar. The powdery material on the wear track of the sanded disk was analyzed by X-ray diffraction and no MoS_2 was found. The powdery material
